## BLACKFEET COMMUNITY WATER PROJECT

August 19, 2002

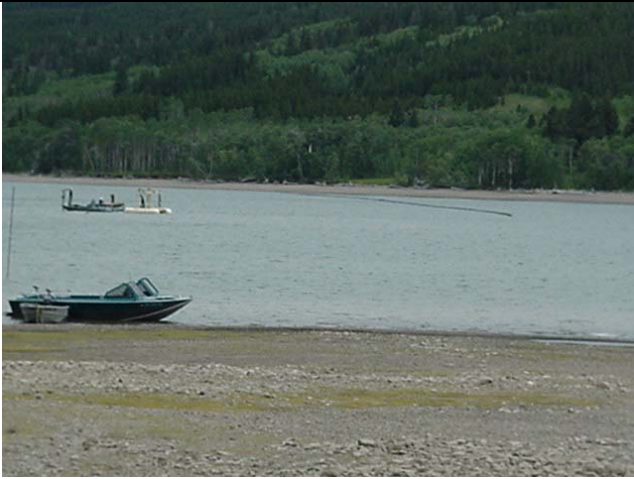
White/green floats at approximate point that intake screen assembly will rest on lake bottom. The HDPE pipe is floating just to right of floats.

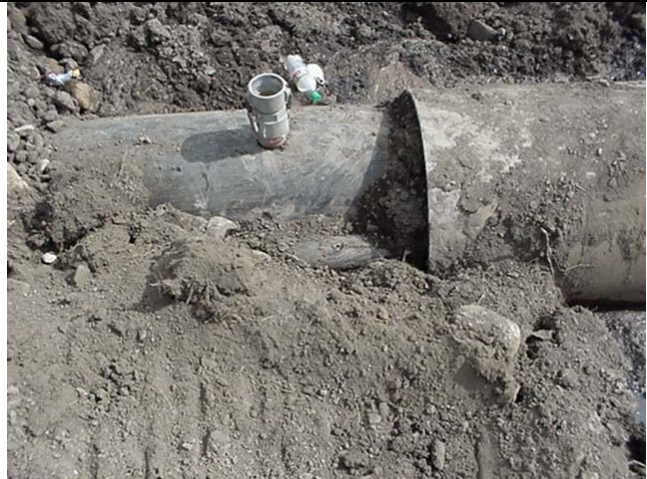
Intake pipe exposed on lakeshore after pull back has been completed.

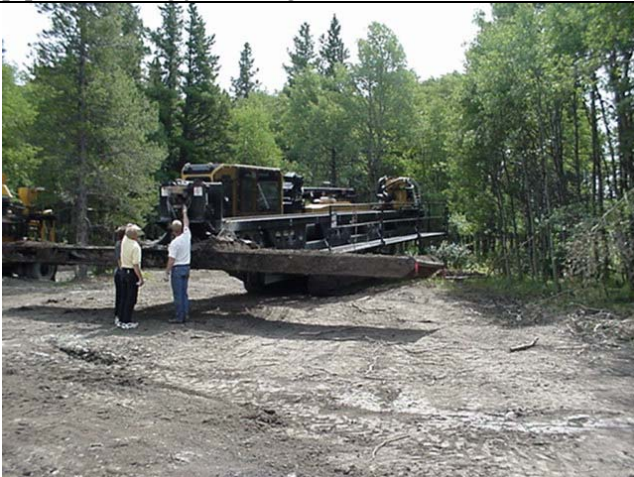
Vermeer drilling machine is being moved as work is done.

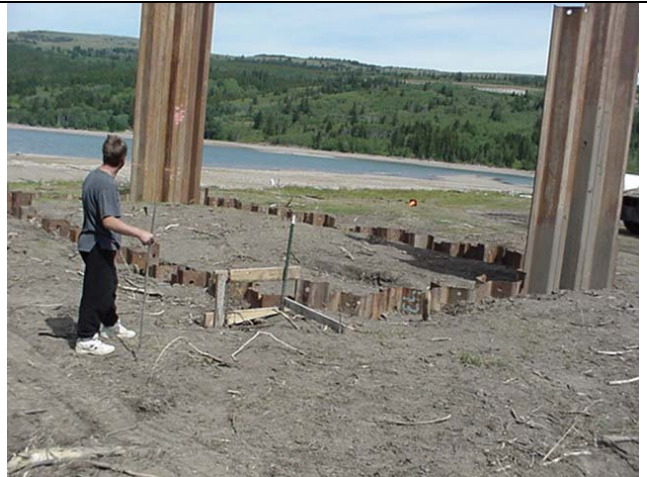
Sheet piling in place. The two elevated pieces were driven to a depth that would not interfere with the intake line as it was pulled back to shore.
